Project Details

Project 3: *High Level Repairs to St. Philip's & St. James's Church,
Ratby, Leicestershire
Diocese of Leicester*

Listing Status: *Grade II**

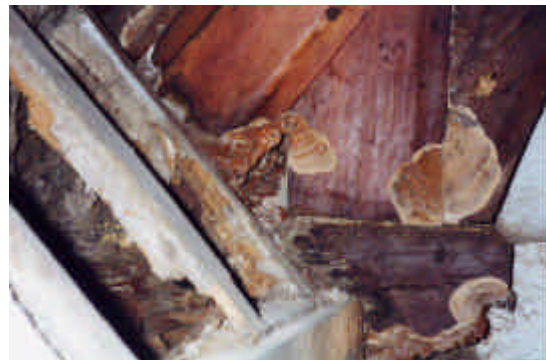
1. Investigations of the extent of the dry rot out break were undertaken at various sections along the arcade. The rubble and plaster in fill between the rafters was removed in these limited areas and they revealed

that where the timbers were contained within the fill they had almost entirely rotted away. The rafter ends were therefore taking their support off the fill. Further investigation and opening up was then suspended. A decision to close the church was agreed with the PCC, Messrs Rowland's Structural Consultants (Structural Engineers) were appointed to advise on the scaffold design necessary to support the roof structure whilst repairs were undertaken. An emergency faculty was obtained and the specification for the remedial works prepared.

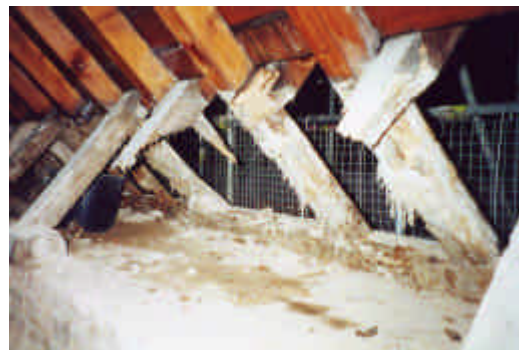
5. The remainder of the in fill between the rafters was removed; this exposed the full extent of the damage. The two inner roof slopes of the nave and the south aisles were stripped and the slates stacked on

- specially extended and strengthened scaffold platforms either end of the valley. The roof boarding was removed and discarded, this revealed that serious damage to the lower sections of the trusses had also occurred.
6. All infected timber was cut away up to the first purlin and trusses were cut back by one meter beyond any timber infection. The timbers were then treated. All ironwork from the original truss feet was recovered and cleaned and painted. New thrust blocks and truss rafters were fabricated to original dimensions and details.

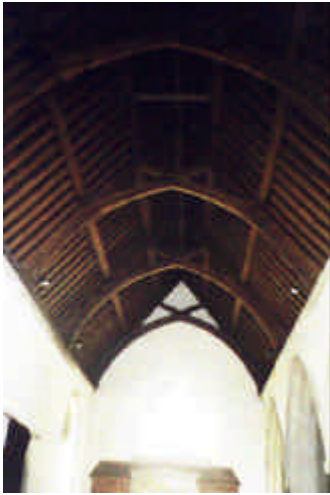
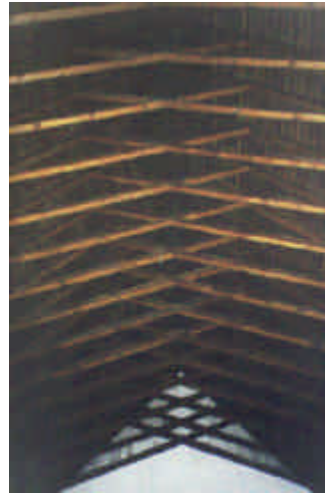
1. The roof as it appeared at the time of the Quinquennial inspection, there was evidence of fruiting bodies but the full extent of the damage was

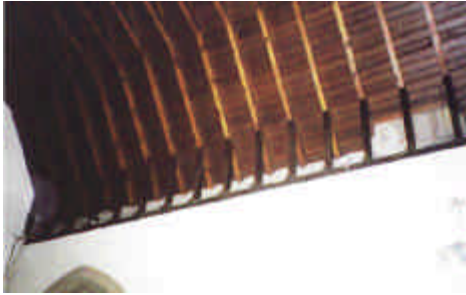
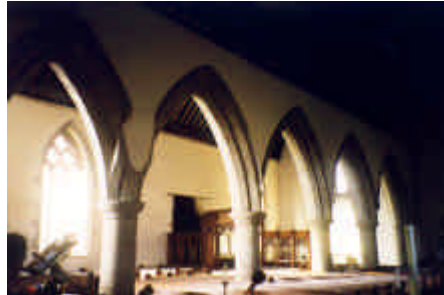
2. The image on the right shows the arcade above which was the intersection of the nave and the south aisle as shown in the image on the left, where the purlins crossed was rubble in filled and plastered, this limited drying through ventilation and caused the rot problem

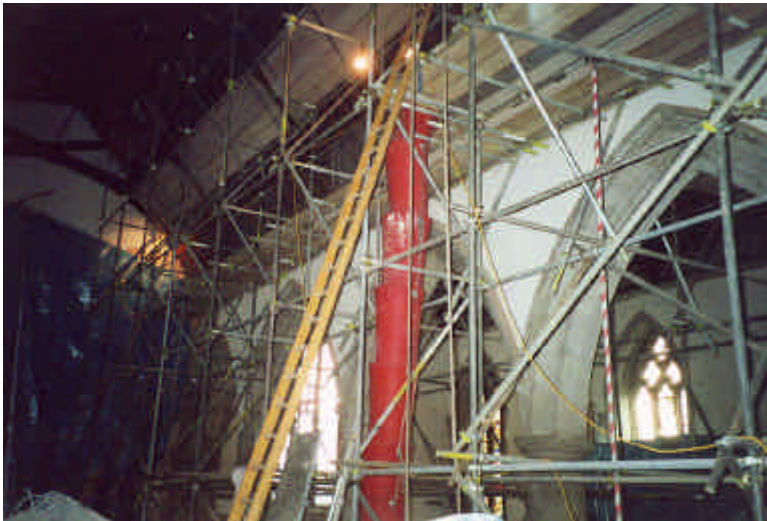
3. Scaffolding along the nave and aisle propping the roof and providing easy access to the affected areas

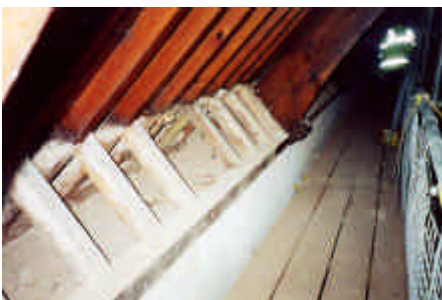
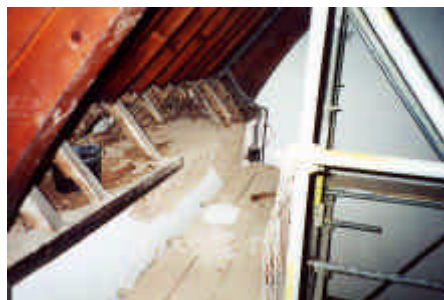
4. The extent of the damage to the roof structure was revealed once the in fill was removed

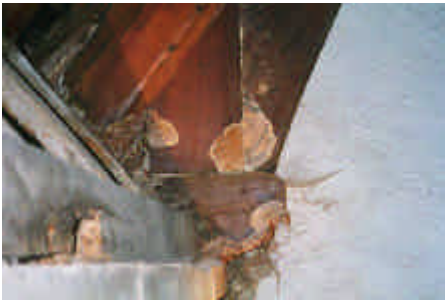
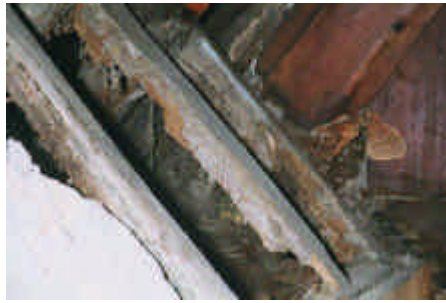
5. The image on the left shows the fruiting bodies on the outside of the main truss timbers, right shows the cubing of the rafters

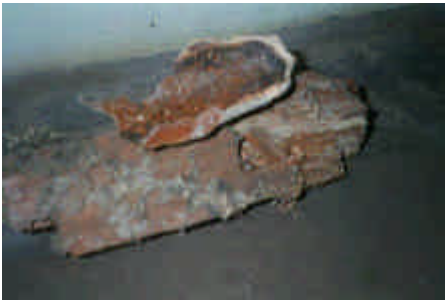
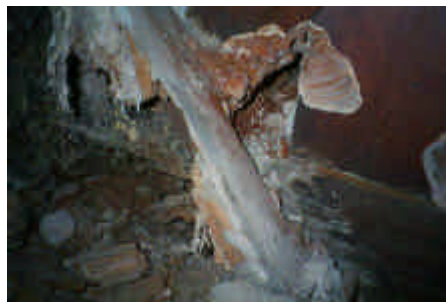
6. Right is a rafter which has crumbled when removing the in fill, it is clear from the picture on the left how the front faces of the rafter were intact and not revealing the extent of the damage

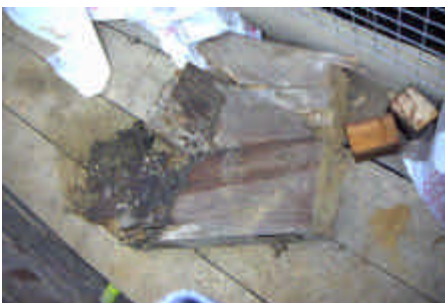
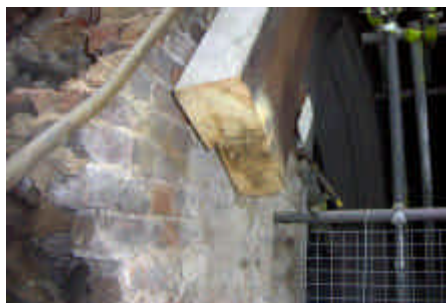
7. These images show the main trusses being cut back and how the rot has travelled in the left hand picture up the centre of the timbers and again is not evident externally, this truss had to be cut back further than first thought
