Project Details

Project 3: *High Level Repairs to St. Philip's & St. James's Church,
Ratby, Leicestershire
Diocese of Leicester*

Listing Status: *Grade II**

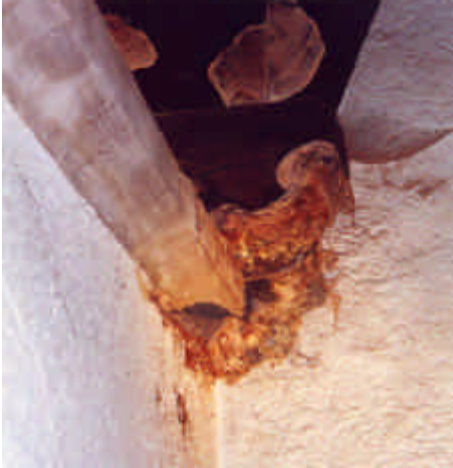
The Quinquennial inspection had revealed a serious outbreak of dry rot in the roof timbers above the arcade to the extent that the church had to be closed.

The necessary repairs to the timberwork would entail cutting away all infected and replacing all timbers below the first purlins. A structural scaffold would be required to support the retained structure during the remedial works. This scaffold would need to be founded upon solid ground and the pew staging was not considered adequate and therefore had to be removed. The war memorial screen also had to be removed away from the arcade and the removed pew staging.
